US Army Corps
of Engineers
Construction Engineering
Research Laboratories

USACERL Technical Report FF-93/09
July 1993

Eight-Year Summary of Fort Irwin, CA, Family Housing Comparison Test: Operation and Maintenance Costs of Manufactured vs. Conventionally Built Units

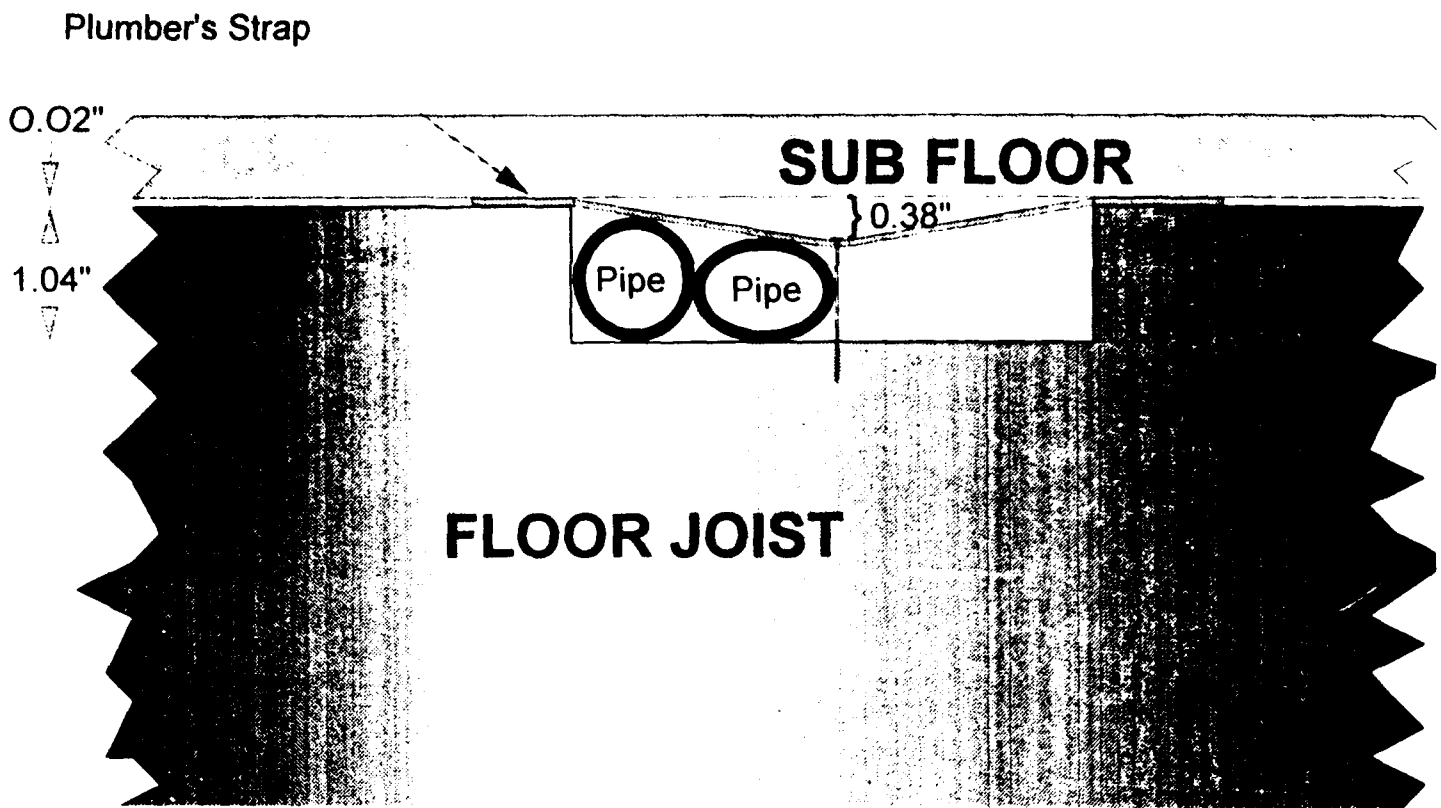
Figure F13: Drawing of Crushed Pipe Site

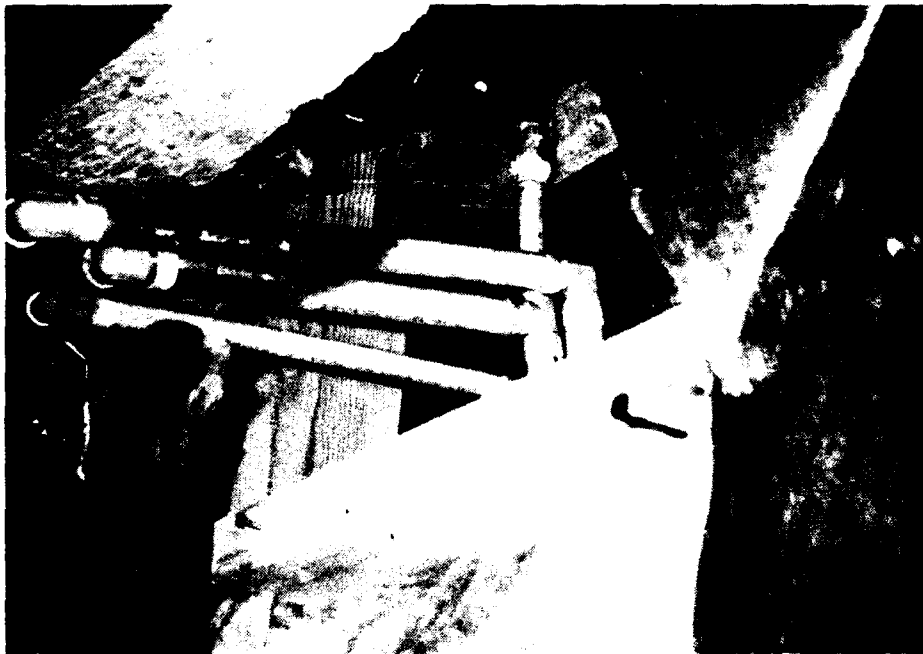
Figure F14: Previous Leak Repairs in Crawl Space under Unit A

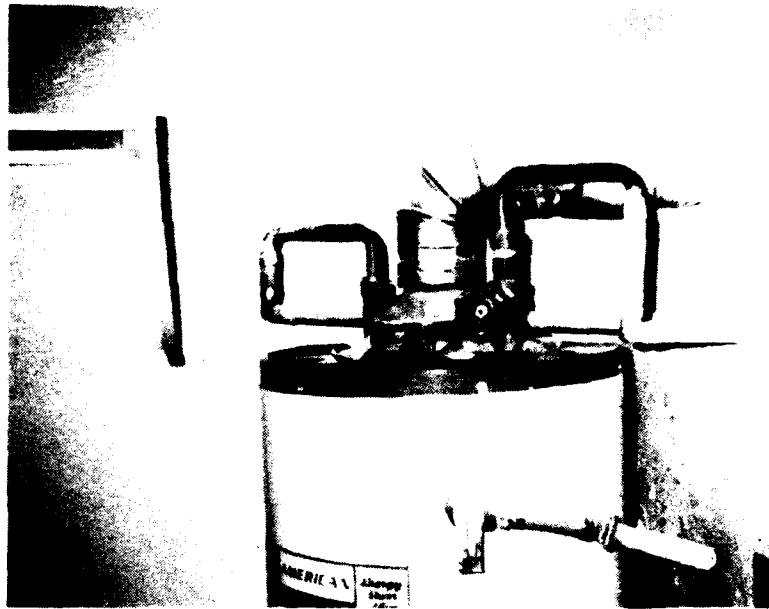
Figure F17: Plumbing Repairs at Hot Water Heater in Building 3804, Unit A

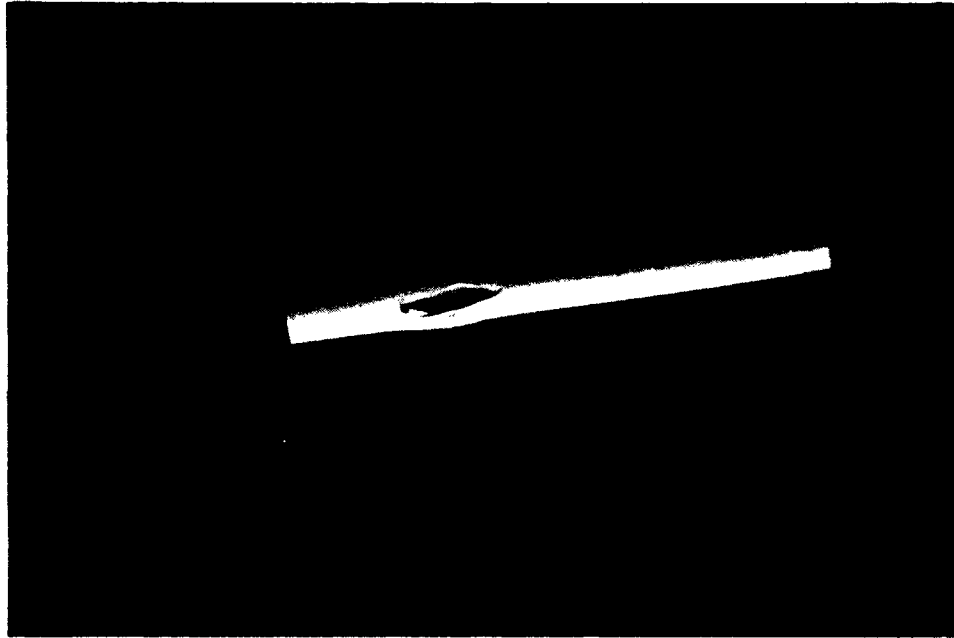
The visual examinations of the polybutylene pipe failures revealed that at the locations where leaks occurred, the pipe cross-section was oval shaped instead of round. Four sections of failed polybutylene pipe were secured for investigation as to the cause of the failures: two were provided by Mr. Walt Perry and two by Mr. Don Andrews. One pipe provided by Mr. Perry (Figure 19) was ruptured, having a hole 1.56 inches long (in the longitudinal direction) and 0.44 inches wide. There were two long narrow strips of pipe wall material broken free

Figure F19: Ruptured Polybutylene Pipe from Building 3858, Unit C

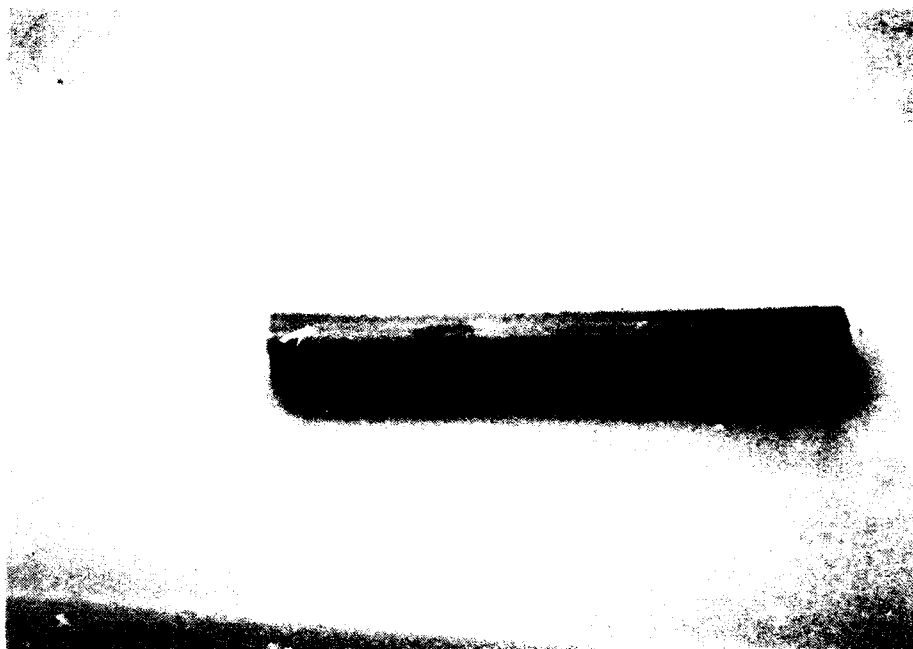
Figure F20: Longitudinal Hair Line Crack in PB Pipe from Building 3802, Unit B

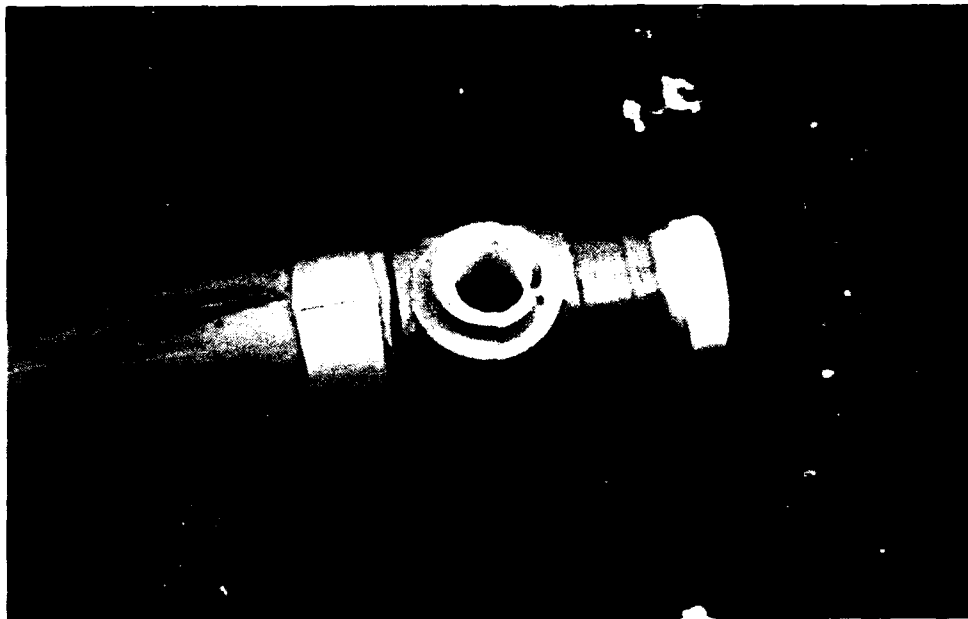
At the completion of the long term chemical resistance testing, there was evidence of chemical attack of the acetal fittings in all three environments. One evidence was the presence of a fine grey powder suspended in the bottom of the jars. The powder was filtered, dried and weighed. The dried powder became the same white color as the inside coating of the fittings. The drinking water sample contained 0.023 grams of powder, the potable water had 0.097 grams, and the Chlorox filled jar had 0.223 grams of suspended particulate. The fine powder was evaluated by IR Spectroscopy. Figure 26 is the spectrograph of the drinking water test residue and Figure 27 of that from the hypochlorite solution test. (The residue from the potable water test was accidentally thrown into a trash container and lost before KBr pellets were made.) The other indicator of chemical attack was the visible start of discoloration on

Figure F22: White Coating on Acetal Fitting Where Exposed to Water

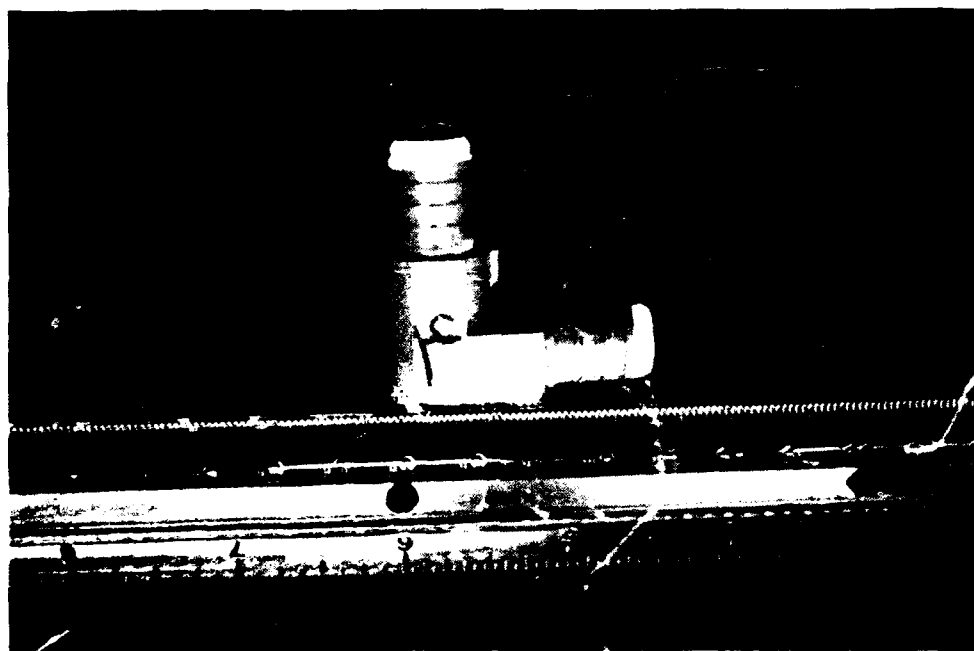
Figure F23: White Coating on Acetal Fitting Where Exposed to Water

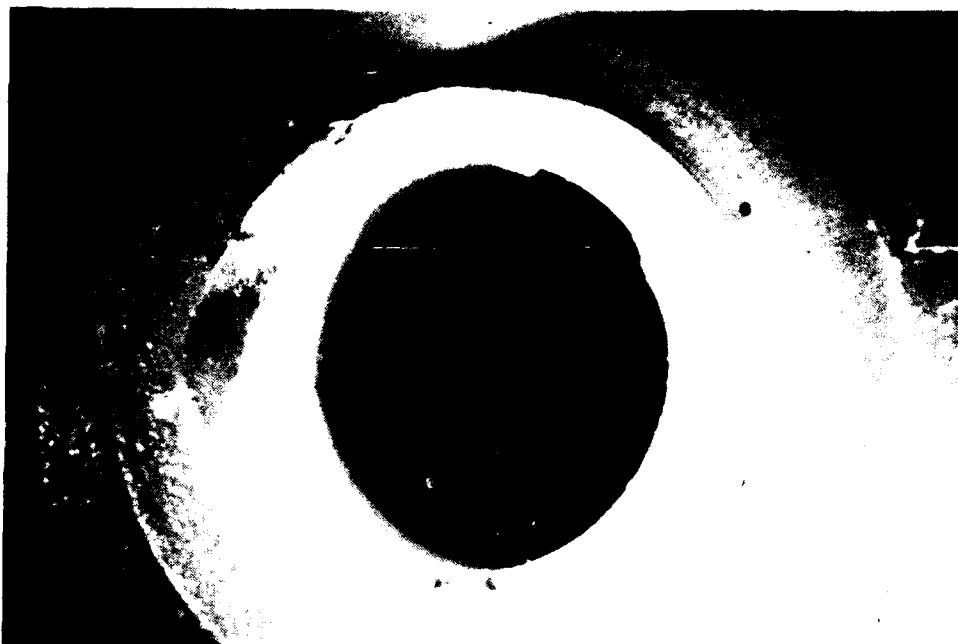
Figure F24: Typical Ft. Irwin Acetal Fitting Fracture Surface

The major reason for the pipe fittings to fail at Ft. Irwin was, therefore, a combination of the stresses induced by crimping coupled with the hypochlorite content of the water.

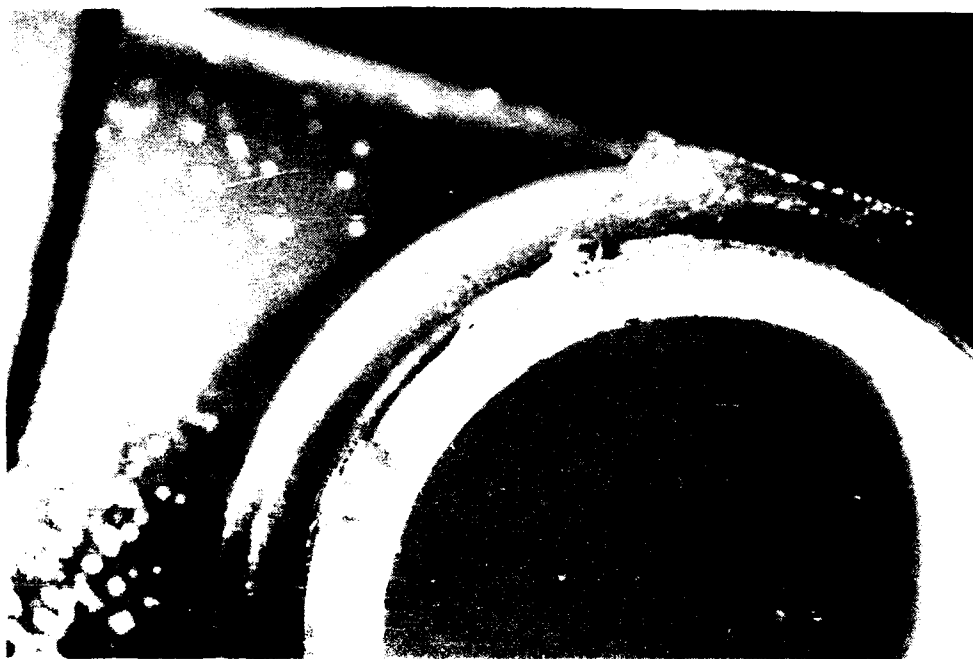
Figure F25: Typical Ft. Irwin Acetal Fitting Fracture Surface

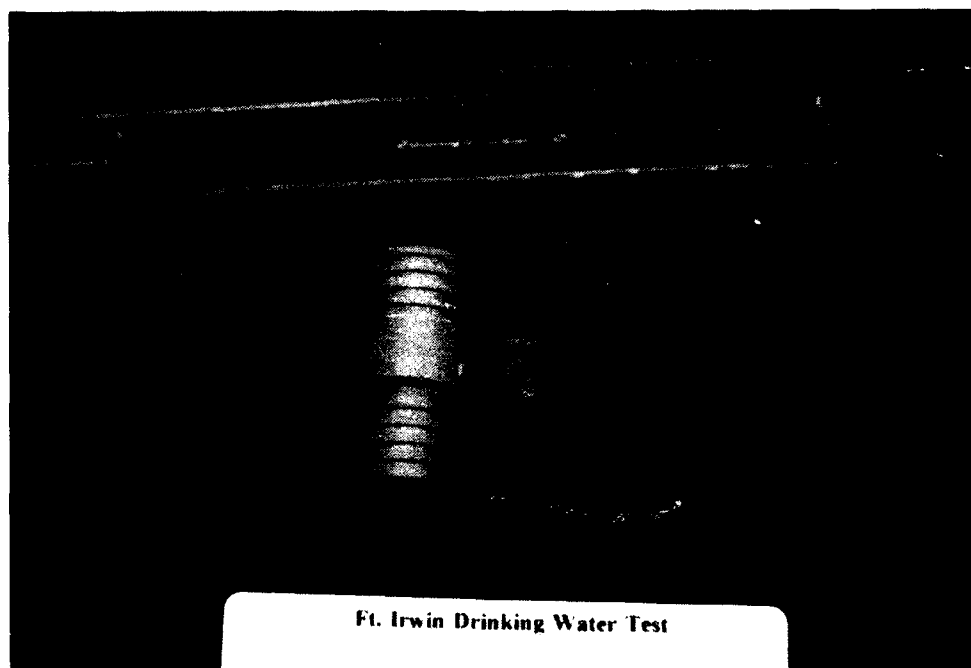
Figure F28: Acetal Fittings Exposed to Ft. Irwin Drinking Water
